Another little job: No1, Princess Marina piston rod repair – Roger Stephen

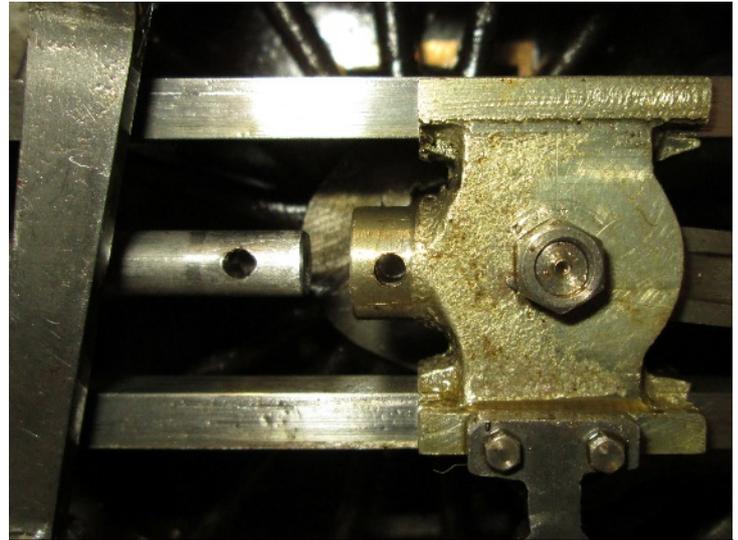
Whilst demonstrating my Princess Marina on Tony Mason's track at last year's club exhibition she suffered an embarrassing failure: the left hand piston rod parted company with the crosshead. On my loco the design of this joint is rather poor – the plain end of the rod is held in a boss on the crosshead by a plain 3/32 inch diameter pin which is supposed to be a press fit but is actually loose. If this method is used it should really be a taper pin (or preferably two of them) which jams itself in. The pin had actually fallen out some years ago while running at Chipperfield and I had glued it back in with Loctite Retainer and I am amazed how long it held together! For reasons I can't remember I had replaced the one on the other side by a roll-pin which has proved absolutely fine except that there is a tiny bit of play in the joint which I don't like at all.

The joint between the piston rod and the crosshead had failed when the plain pin fell out. It had been held in with Loctite Retainer for some years!

So I spent time over the winter hatching a repair plan and decided I wanted the piston rod to screw into the cross-head boss and then be held in with a pin of some sort. I ascertained that the cross head boss could be drilled and tapped 5/16 x 40 ME to receive a threaded steel insert to match. The insert would also be drilled and tapped 7/32 x 40 ME to match a thread on the end of the piston rod. Then I could assemble the joint, cross-drill the insert hoping to line up with the original retaining pin hole in the rod (yes I know it won't quite but I'm an engineer, not a mathematician), press a roll-pin in and job done. Easy.

Oh no it isn't! To do that I would have to get the crosshead out from between the guide bars. So I started to dismantle the motion all around it. That was simple enough but it very soon became apparent that to get the crosshead out I would need to remove the crosshead guide bar bracket which supports the rear end of the crosshead guide bars. The bracket is bolted to the loco frames and to get it off I need access to the bolts which means I have to take the boiler off. Blow that for a game of soldiers – I'll put a roll pin in the crosshead/piston rod joint like I did on the other side! I will keep my fingers crossed that holds for now and make the joint properly next time I have to take the boiler off.

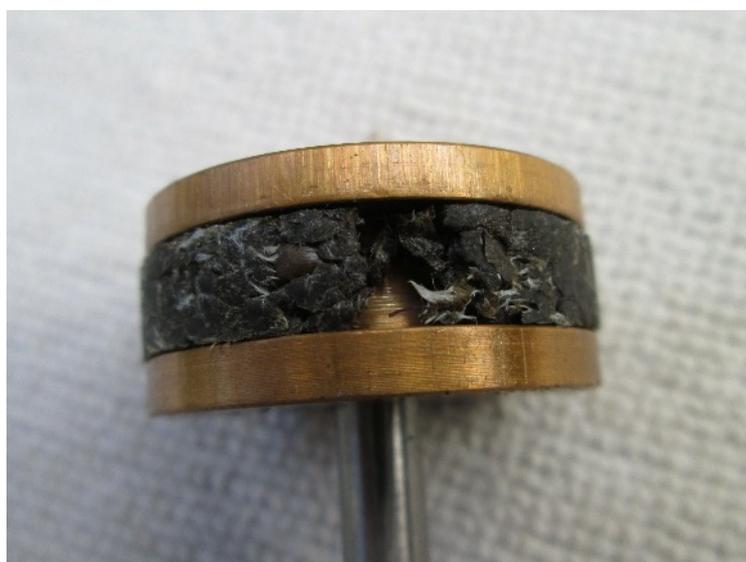
The 3/16 inch square graphited yarn had spread in the 1/4 inch wide piston groove and the joint opened up by about 1/8 inch. Not a good way to make a seal.

So I put the motion back together but before I put a roll-pin in the failed joint I took the opportunity of taking the piston out of the cylinder to look at the piston packing. I had suspected there was some 'blow-by' reducing the locomotive's power and thought it would be a simple job to replace the packing and restore the power. The piston came out easily enough – eight 6BA screws, off came the front cylinder cover and out came the piston and rod. Then the revelation: the groove in the piston was 1/4 inch wide and 3/16 deep. In it was a length of 3/16 square graphited yarn rope. Well, I think it was that size when it started but because the groove was so wide it had been able to spread sideways so it wasn't pressing the cylinder wall so well or not at all. As it spread it shortened and the joint

between the yarn rope ends had opened up to about 1/8 inch wide. No wonder there was blow-by!

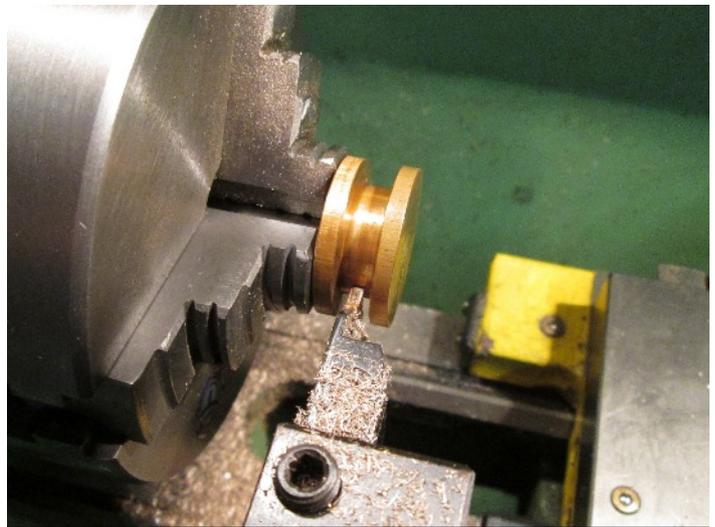
Making the piston groove deeper using a parting tool in the lathe. I took it from 3/16 to 1/4 inch deep for 1/4 inch square rope.

Now to my knowledge 3/16 by 1/4 inch graphited yarn has never been a standard size so why the piston groove was that size I don't know, although it does look like that in LBSC's original loco drawings and he says to pack the groove with graphited yarn. I had been expecting the groove to be 1/4 inch wide and deep to take 1/4 square graphited yarn rope and had previously bought some for the job. However, I had also discovered 6mm square PTFE braided rope gland packing on Ebay and thought that might perform well so I had bought some of that as too. That turned out to be lovely hard stuff about 6.5mm square (same as the 1/4 square yarn) to allow for some compression. Rather than try and cut the 1/4 inch rope down to fit a 3/16 deep groove (silly idea!) I did the sensible thing and put the piston and rod in the lathe and, using a parting off tool, carefully deepened the groove to 1/4 inch.

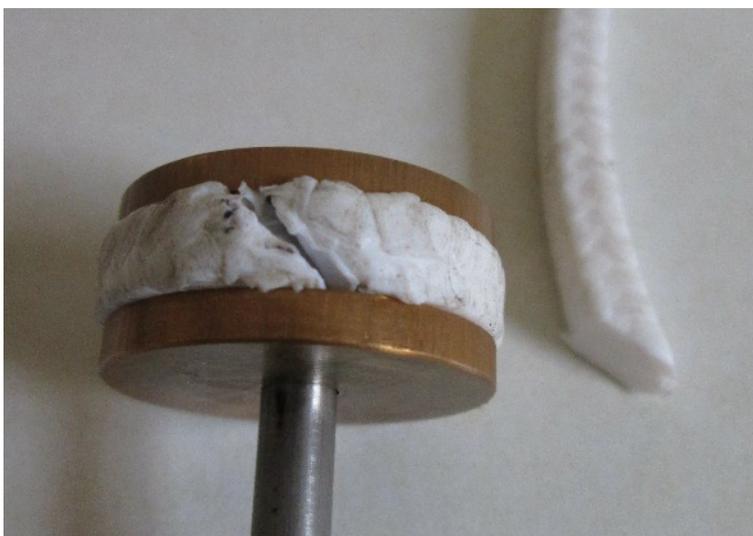
The piston fitted with new square PTFE braided rope gland packing ready for squeezing back into the cylinder. Note the ends are cut at about 45 degrees to make an overlapping scarf joint.

I decided to try out my PTFE rope and cut a piece slightly long with the ends trimmed at 45 degrees to make an overlapping scarf joint when wrapped round the piston groove. It needed a little more trimming when wrapped round but when I was happy I oiled it and put the piston back in the cylinder, poking and prodding the PTFE rope to compress it into the piston groove and cylinder bore as I did so. It was very fiddly but eventually it went in OK and I then brought the crosshead and piston rod together, tapped a roll-pin into the cross drilling and put the cylinder cover back on with a new oiled brown paper gasket (no need for fancy gasket material here – just ordinary brown paper and a bit of Castrol GTX!). Job done that side. While I was at it I did the same thing with the piston on the other side, the roll-pin tapping out and the joint coming apart quite easily.

Previously there had been very little resistance when Princess Marina was pushed up and down a length of track. Now you could definitely feel when the air in the cylinders was being compressed as she rolled along. It looked promising. A week later Den and Malcolm did a steam test for me in which the loco was

put on a rolling road and fired up. As soon as the regulator was cracked open in forward gear the wheels began to turn. Previously she had been reluctant to get going without a bit of manual wheel turning until warmed up so I am optimistic her power has been restored. The proof of the pudding (and how durable the PTFE rope is) will be revealed on a run at the Puffing Field which is proving frustratingly elusive but I hope will happen soon. Watch this space for an update.

(Here's the update! Performance at the track is much improved and Princess Marina now even does passenger hauling, which was a bit of a nightmare previously. After some 21 hours of running the PTFE rope seems to be holding up OK too.)
