## Another little job: No 2, A new grate for Princess Marina – Roger Stephen

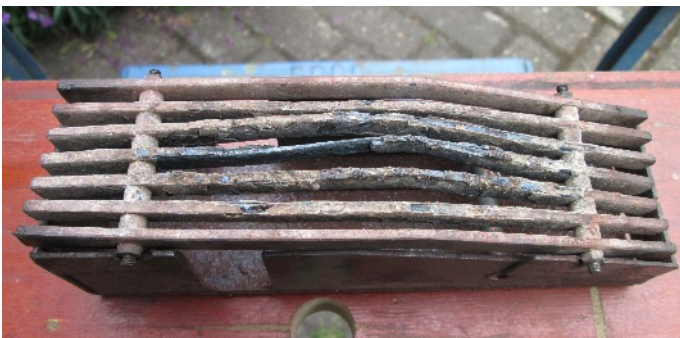
Whilst doing the piston rod repair on my Princess Marina I remembered that the grate was starting to look a little second-hand. The grate comprises seven  $1/8$  inch by  $5/16$  mild steel bars with  $3/32$  spacers between them, these being held together by two  $1/8$  inch diameter studs with 5BA nuts on the ends. After more than 90 hours running in my ownership (and some before that?) the centre bar was badly burnt, down to about  $1/32$  inch thick in the middle and had bowed upwards by about a quarter of an inch, and the ones either side of it were not much better – see photo. Rather surprisingly the 5BA studs and the spacers were still in good condition for reuse, as were the two outermost bars. So, simple job: cut some new bars, bend them, drill them and bolt the grate back together. Or so I thought.

*The original grate was severely burnt and somewhat distorted after more than 90 hours running in my ownership.*

Now I could have just settled for deeper grate bars than the original  $5/16$ , which would probably perform OK and save me some work, but I like to do things right. So I finished up putting five bits of my steel strip on the milling machine and chomped away at it until it was down to  $5/16$  inch wide. Then I bent and drilled each bar, using an original side grate bar as a template, and cut them to length leaving the simple job of bolting it all back together which was fine – see other photo. Job done, but it did take a bit longer than I intended. I wonder what the stock sizes of steel will be when my Princess Marina has done another 90 hours running. With luck I can get 3mm by 8mm – or find a friend with a guillotine.

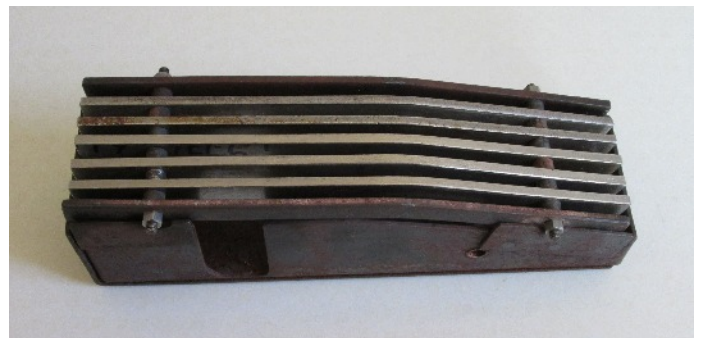
*The new grate ready for another 100 hours running? Note the gap in the side of the ash-pan where the rear axle passes through!*
