The ups and downs of buying a model steam locomotive. Part 6: The boiler repairs begin - Roger Stephen

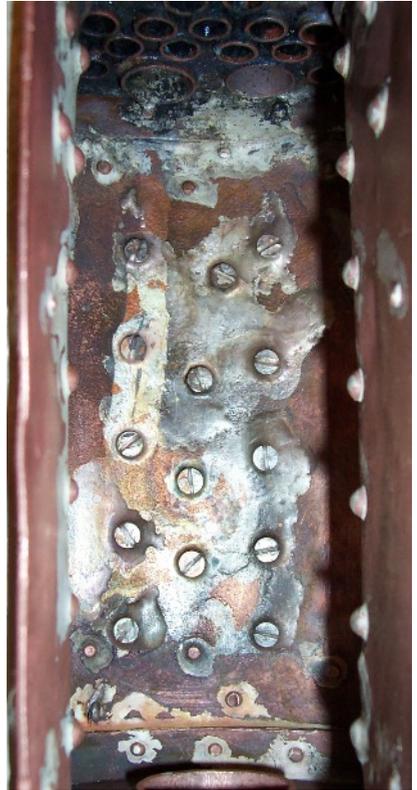
The view inside the firebox. The ten new rod stays are easily visible with the four 4BA screws down the middle (not in a straight line to hit the centre Tee girder stay flanges).

Back at home I set to making my bronze rod stays and a new bronze regulator bush on my lathe, the 4BA bronze screws having been bought from a model engineering supplier. The stays had a small head on one end (so as not to pull through the firebox crown) and a 2BA thread on the other to screw into the outer wrapper. Drilling down into my boiler was straightforward and, fortunately, the drill went exactly where I wanted it to and it did not hit anything important (like cross and longitudinal stays) on the way through! I put a tap through the holes in the top of the boiler then turned it over and opened out the holes inside the firebox to clearance size and drilled and

tapped the holes in the centre girder stay for the 4BA screws. I did not like the small flange on LBSC's regulator bush so I made mine with a wider flange and with nice deep blind holes to mount the regulator. Cutting away the original regulator bush on the boiler was a bit of a game: basically a manual process of filing and carving it down using my mini-drill with a dentists burr in the chuck. It was slow and fiddly but not difficult. Time to see Ian Ferguson.

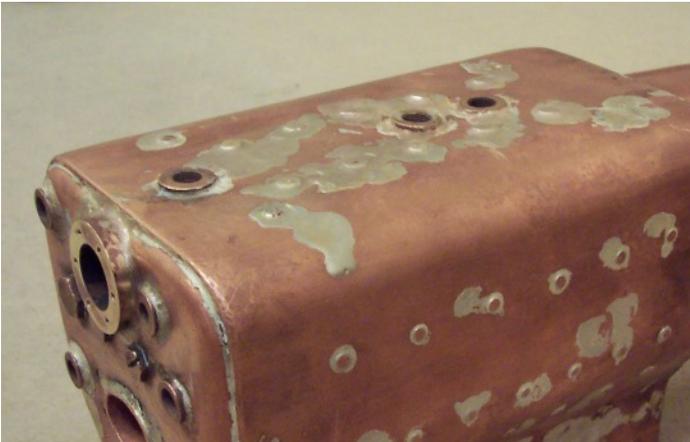
The new rod stays and regulator bush were perfect: it was everywhere else that I had not touched that now leaked. Some of the firebox side stays were weeping and the blind nipples

The top of the boiler with the new rod stays neatly soldered in and filed almost flush. The new regulator bush has a nice wide flange and a good fillet of solder all round the outside. The main repair is done but now there are lots of leaks to seal!

of the longitudinal stays were leaking big time. I suspected this was mainly the effect of some good long soaks in the acid pickle dissolving some scale and jointing compound that had previously made a good seal. Anyway, another trip to Ian Ferguson's evening class improved most of the leaks, and I silver soldered some bronze screws in the cladding screw holes, but that still left a few leaks and the blind nipples. Now how do I deal with those?
